Veolia New Zealand

Wigmore Stream, Hahei

Flow Monitoring Report 21 February 2019

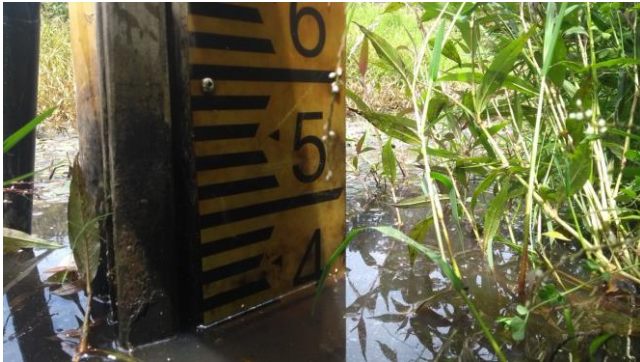
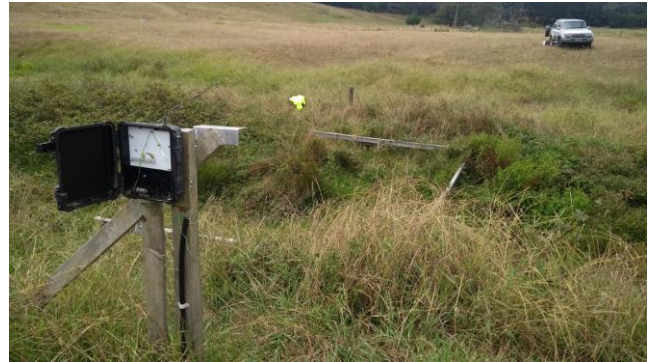
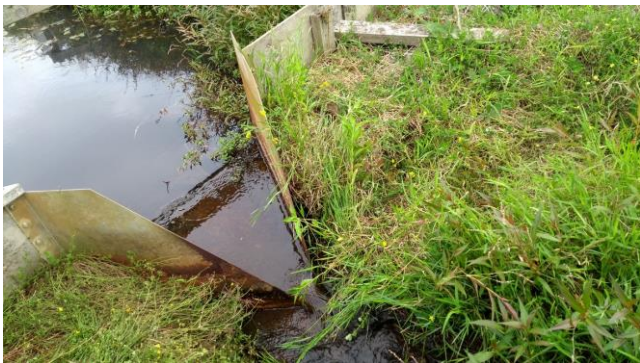
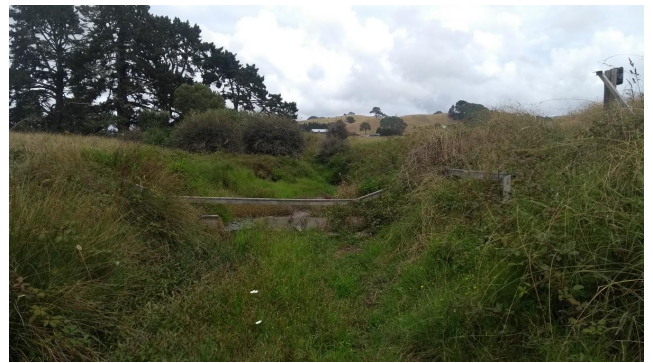
Site Photos:

The recent site visit was completed on 21 February 2019 for a flow gauging. The weather conditions were fine with no rain or wind. The stream was full of weed with very low flow.

The weir (H Flume) was inspected and was found to be in below average condition – the weir itself is now on a slope falling 35mm over its 670mm length. The electronic monitoring equipment had been removed. The staff gauge was in good condition with no sign of movement.
